# Dorchester County, Maryland Shoreline Situation Report Methods and Guidelines

October, 2003

## **Shoreline Situation Report, Methods and Guidelines**

Comprehensive Coastal Inventory Program, Center for Coastal Resources Management  
Virginia Institute of Marine Science

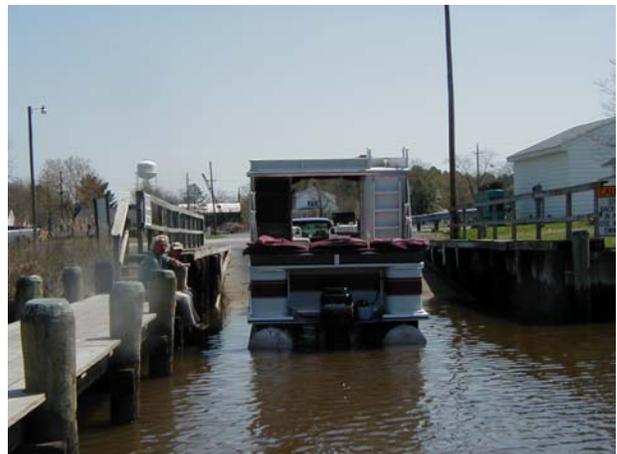
Plate 3

Location: Vicinity of Warwick River

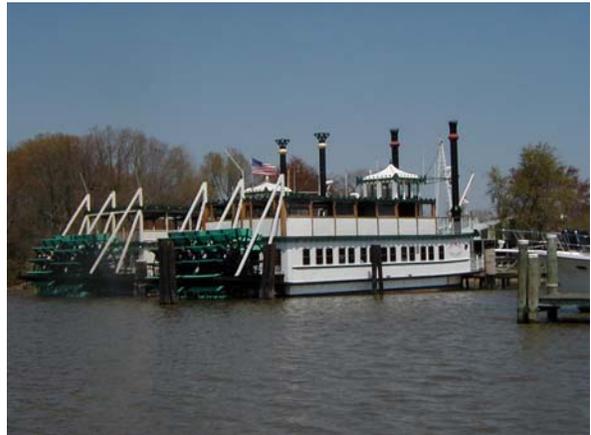
Plate 5

Location: Vicinity of Hurst Creek and White Hall Creek

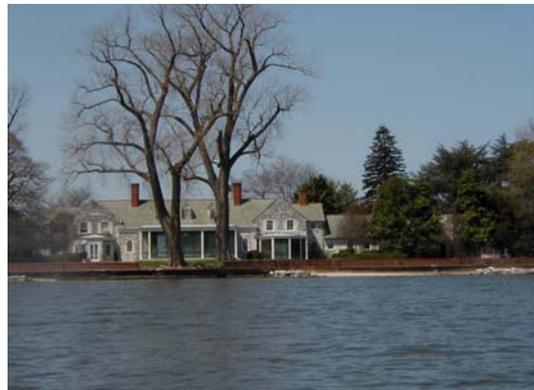
Plate 9

Location: Castle Haven Point to Lecompte Bay

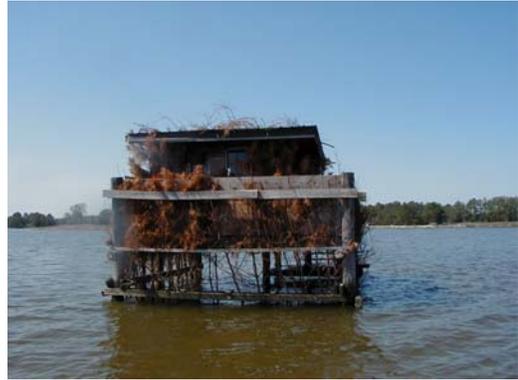
Plate 11

Location: Todds Point

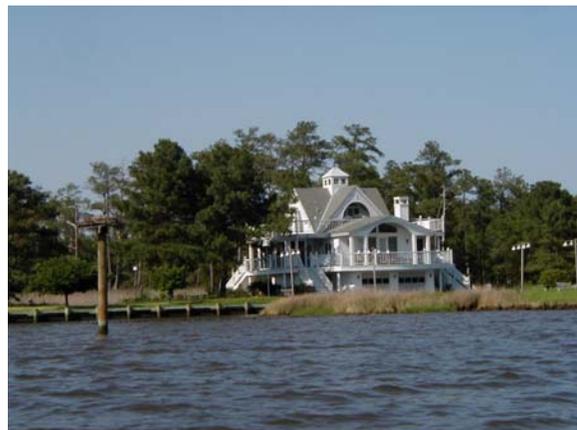
Plate 17

Location: entrance to Fishing and Beckwith Creeks

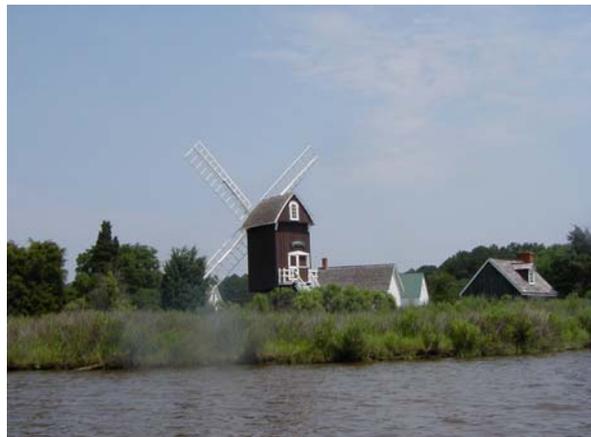
Plate 20

Location: Gary and Lee Creeks

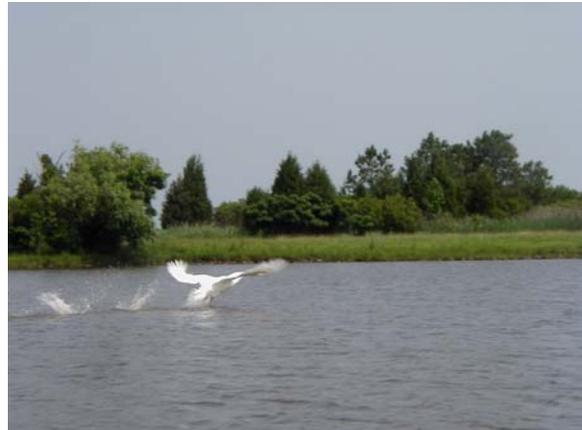
Plate 22

Location: Fishing Creek and Church Creek

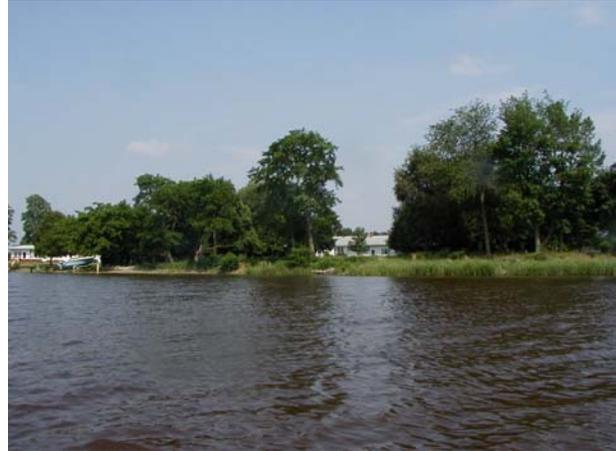
Plate 25

Location: Susquehanna and Wollford Neck

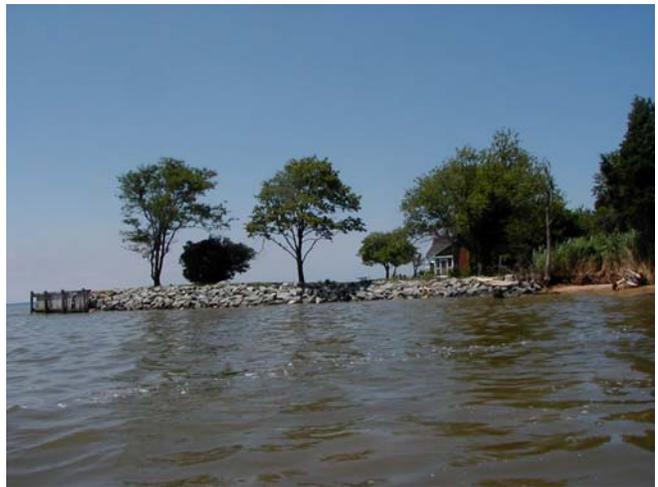
Plate 30

Location: Taylor's Island

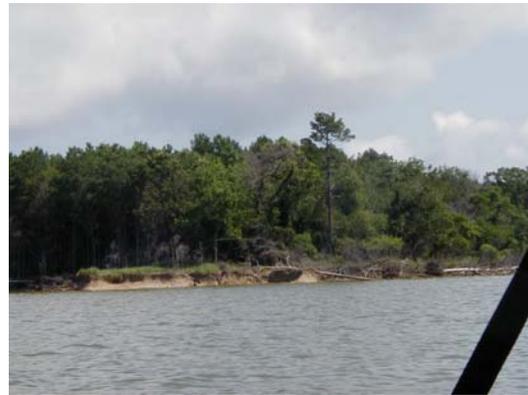
Plate 33

Location: Meekins Neck

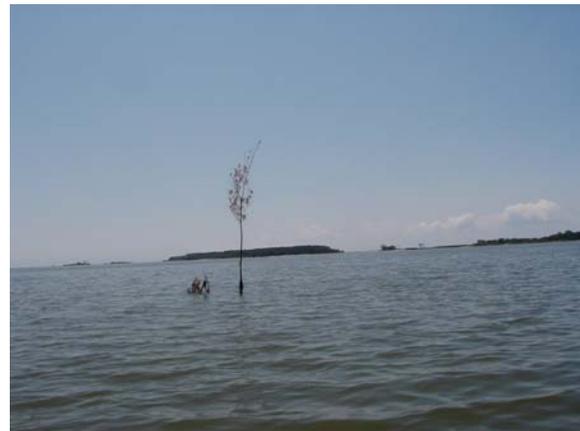
Plate 37

Location: Middle Hooper Island

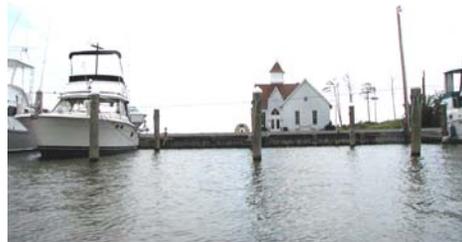
Plate 40

Location: headwaters of Honga with Dicks Point, Great Marsh Creek and Wallace Creek Marsh

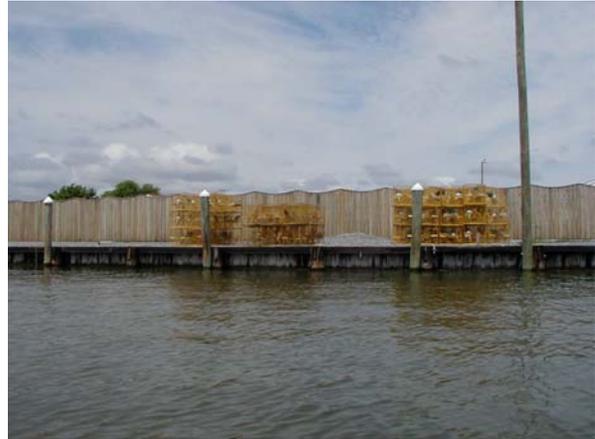
Plate 46

Location: Hearn's Cove to Crab Point

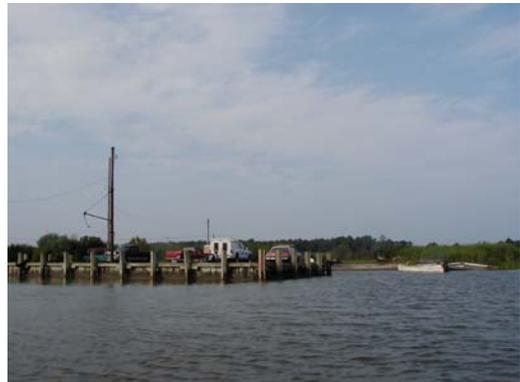
Plate 52

Location: Thorofare Creek to Blackwater River

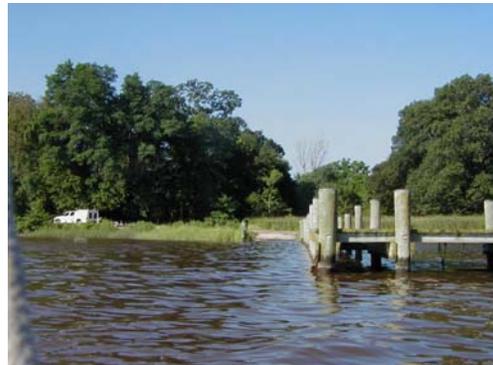
Plate 55

Location: Island Creek and Grays Island Marsh

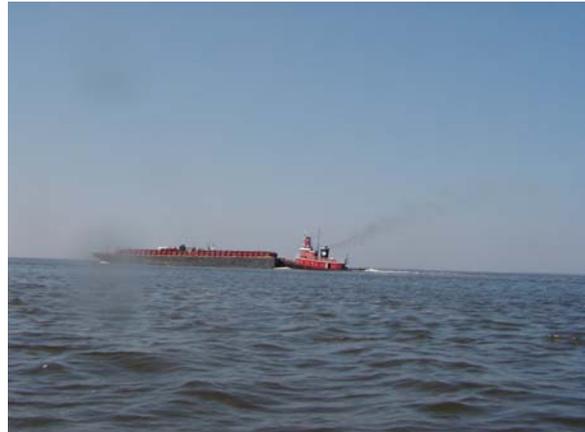
Plate 61

Location: Swamp Creek Cove to Newfoundland Point

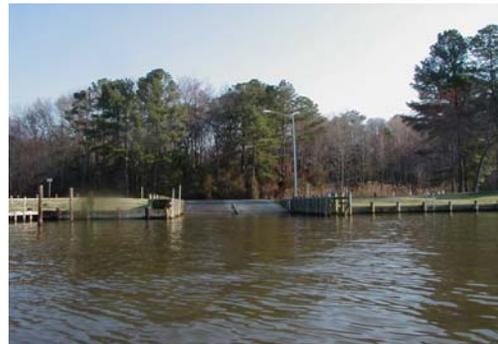
Plate 62

Location: Lowe and Upper Greens Cove

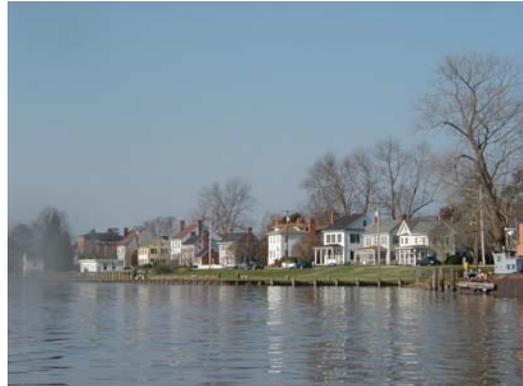
Plate 65

Location: North of Penknife Point to Point No Point Marsh

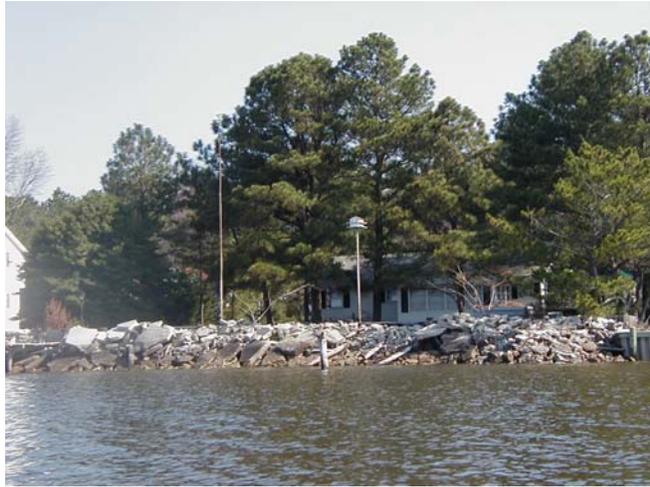
Plate 67

Location: Town of Vienna

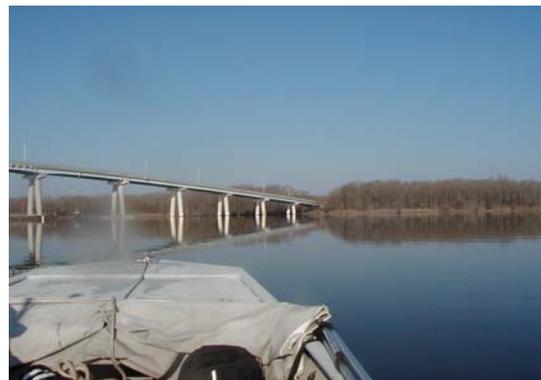
Plate 69

Location: Entrance to Marshyhope Creek
