Development of the Maryland Shoreline Inventory Methods and Guidelines for Somerset County

Prepared by the Comprehensive Coastal Inventory Program,
Center for Coastal Resources Management, Virginia Institute of Marine Science,
College of William and Mary, Gloucester Point, Virginia.

October, 2004

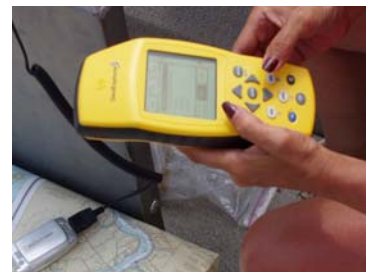
Data collection is performed in the field, from a small, shoal draft vessel, navigating at slow speeds parallel to the shoreline. To the extent possible, surveys take place on a rising tide, allowing the boat to be as close to shore as possible. The field crew consists of a boat operator, and one surveyor. The boat operator navigates the boat to follow the shoreline geometry. The boat operator logs information relevant to shoreline structures. The surveyor collects information pertinent to land use and bank condition. Data is logged using either the handheld Trimble GeoExplorer, GeoExplorer 3, or GeoXT GPS unit. These units are accurate to within 4 inches of true position with extended observations, and differential correction. This level of accuracy has not been achieved in this project due to the observation requirements. Both static and kinematic data collection is performed.

Kinematic data collection is a collection technique where data is collected continuously along a pathway (in this case along the waterway). GPS units are programmed to collect information at a rate sufficient to compute a position anywhere along the course. Features are collected at a rate of one observation every five seconds. Land use, bank condition, and linear shoreline structures are collected using this technique.
