City of Norfolk, Virginia

Shoreline Inventory Report

Methods and Guidelines

Special report in Applied Marine Science and Ocean Engineering No. 443 of the Virginia Institute of Marine Science

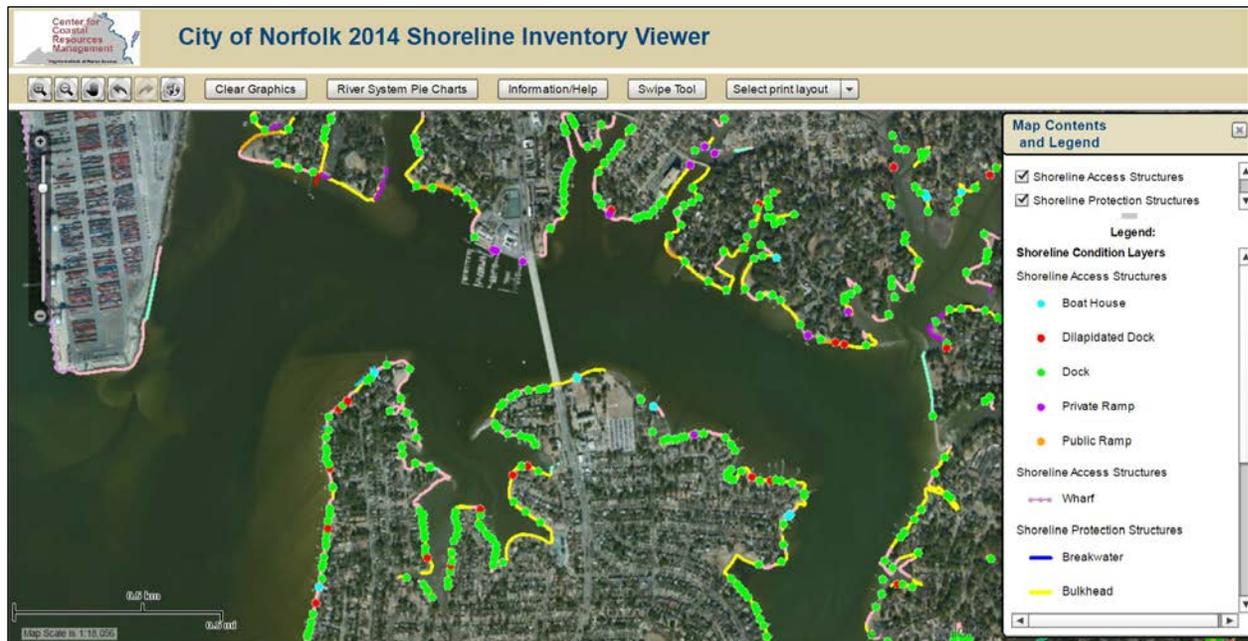
Figure 4. Map Viewer illustrates Shoreline Access and Protection Structures for a section of the City.

In Figure 4 Shoreline Access Structures, and Shoreline Protection structures are selected. Shoreline Access structures are point features that includes piers and boat ramps. The actual footprint of these structures is not measured; only their location. Shoreline Protection Structures are line features and are mapped and illustrated in the viewer to show where they occur along the shoreline. Figure5 illustrates riparian land use in the riparian zone for the same section of the City.

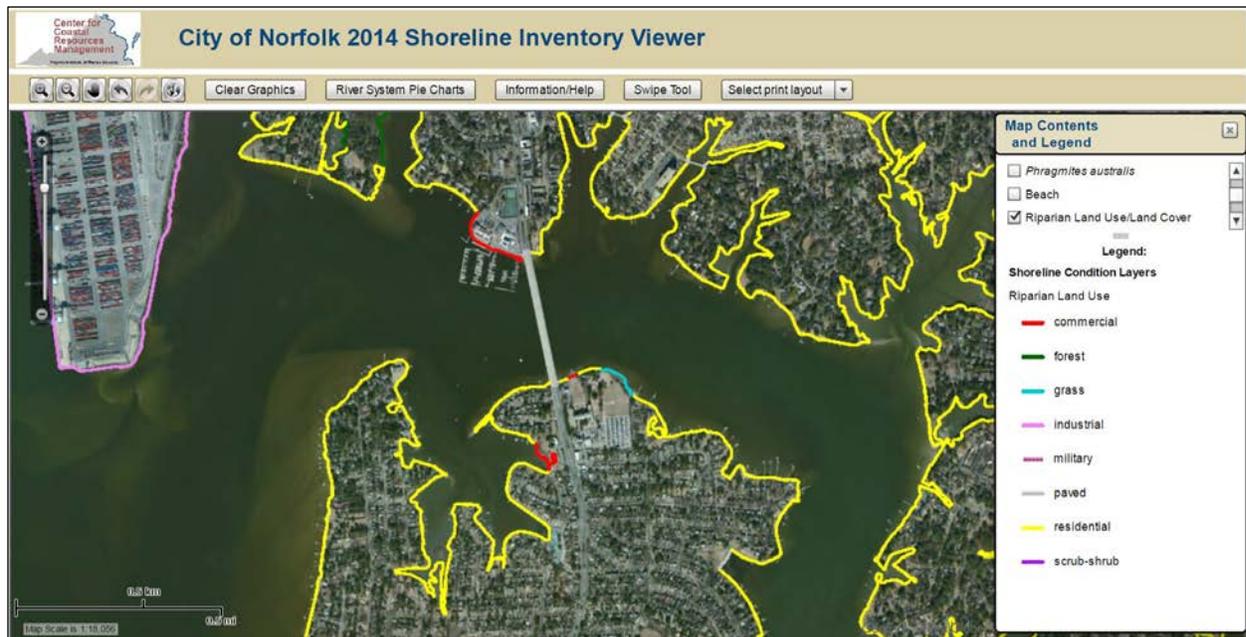
Figure 5. Distribution of land use in the riparian zone is displayed for this region of the City.
