Stafford County, Virginia Shoreline Situation Report Methods and Guidelines

Special report in Applied Marine Science and Ocean Engineering No. 394 of the Virginia Institute of Marine Science

Stafford County - Shoreline Situation Report

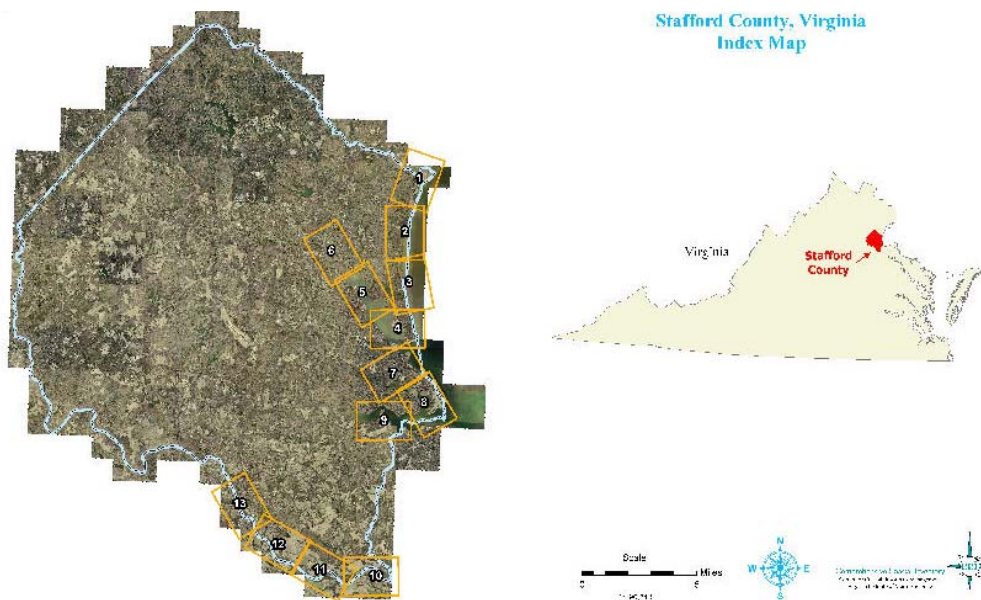
Figure 2. Map index for Stafford County

From the page above, the user will be linked to a project review and disclaimer page where basic project and data use limitations are presented. The link to maps will take you to an index page illustrating the plate boundaries (Figure 2). This is useful if you are interested in a specific area. There are 6 links at the bottom of the disclaimer page. These links are self-explanatory. When you click on “Maps” the county index page will appear. The index illustrates the distribution of plates geographically.

For publication purposes the county is divided into a series of plates. Plates are scaled at 1:12,000 for publication at 11x17. Scale will vary if printed at a different size. The number of plates is determined by the geographic size and shape of Stafford County. An index is provided that illustrates the orientation of plates to each other. The county was divided into 13 plates (plate 1a, 1b, 1c, etc.), for a total of 39 map compositions. On the website, an index is provided to help users locate the area of interest. Each plate can be individually selected and viewed from the plate list along the left hand column of the index page.

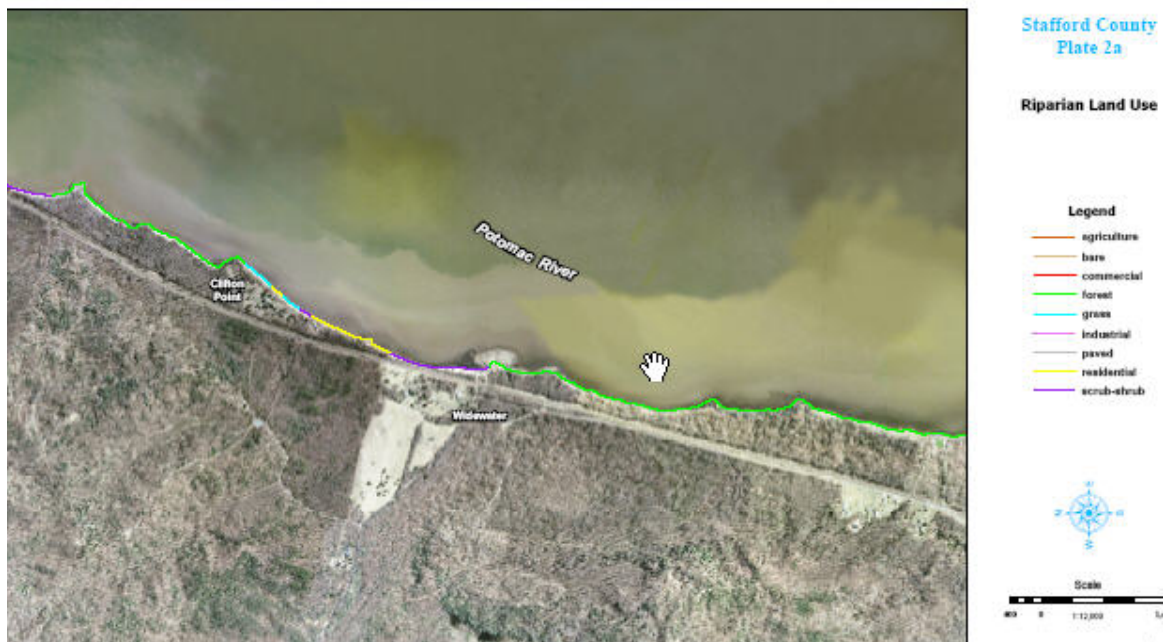
Figure 4. Riparian Land Use map for Stafford County

Plate A describes the riparian land use as color-coded bars along the shore. A legend keys the color to the type of land use. The background imagery is the natural color VBMP imagery at a publication scale of 1:12,000. Users should note that the imagery is sometime rotated in order to meet the scale requirements. This means that “north” is not always to the top of the page.

For example, land use, to some extent, directs the type of management practices one can expect to find along the shoreline. The land use data, illustrated in plate “a” of the SSR series illustrates current land use at the time of survey that may be an indicator of shoreline management practices existing or expected in the future. Residential and commercial areas are frequently altered to counter act shoreline erosion problems or to enhance private access to the waterway. In contrast forested or agricultural uses are frequently unmanaged even if chronic erosion problems exist. Small forest tracks nestled among residential lots have a high probability for development in the future. These areas are also target areas then for shoreline modifications if development does occur. Local governments can do some enhanced and proactive planning if resources allow and the SSR data is readily available. Areas primed for development can be assessed in advance to determine the need for shoreline stabilization, and the type of stabilization that should be recommended.

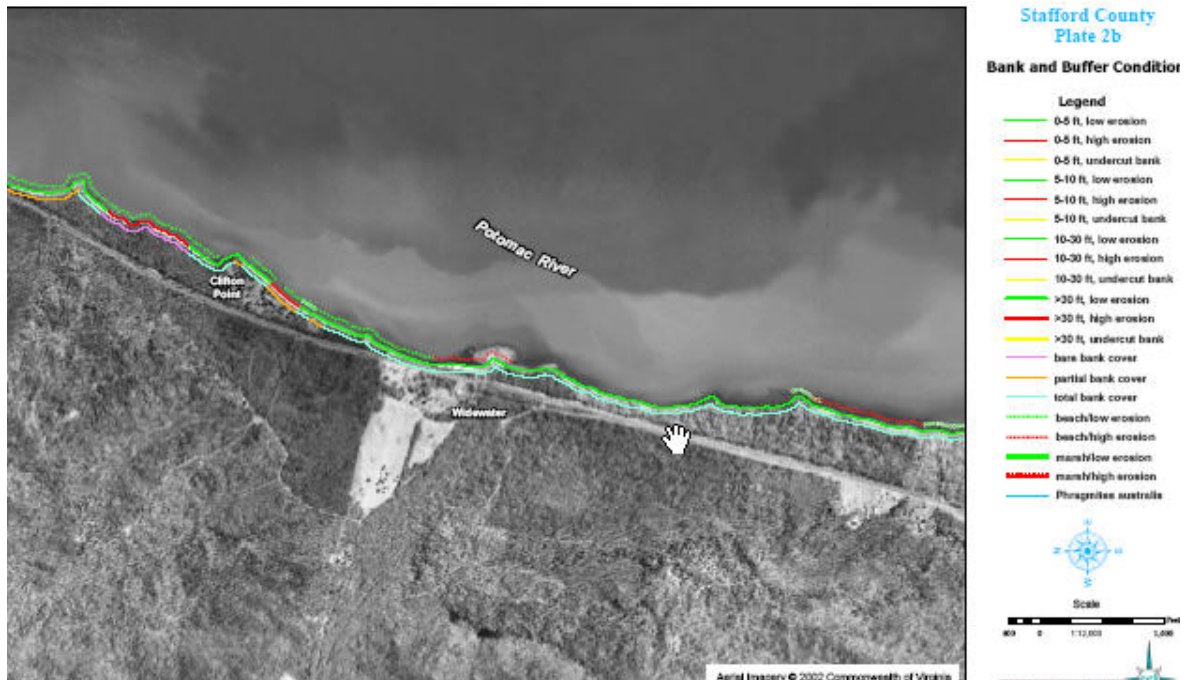
Figure 5. Map illustrating bank and buffer conditions for plate 2 in Stafford County

Plate B depicts the condition of the bank and any natural buffers present. Four lines, and a combination of color and pattern symbology give rise to a vast amount of bank and natural buffer information. The line furthest inland describes the bank cover. Bank cover is distinguished by colors. Bare banks (<25% cover) are illustrated in pale pink, partial cover (25-75%) is pale orange line, and total cover (>75%) is indicated by a pale blue line. Moving toward the water, the next line represents bank height and stability. Bank height varies with the thickness of the line; where the thickest lines designate the highest banks (> 30 feet). A red line indicates the bank is unstable. A green line indicates stability, and a yellow line indicates the bank is undercut. If present a darker blue line will indicate the presence of *Phragmites australis*.

A pattern of small circles just channel ward of the shoreline describes any natural buffers present. Open circles represent a natural fringe marsh along the base of the bank. Solid circles indicate a sand beach buffer at the base of the bank. It is possible to have both. If the buffer exhibits erosion the circles will be red, and green if the buffers are stable. The length of the each of these symbols described along the shore reflects the length alongshore that the features persist. The symbology changes as conditions change. Plate B uses a gray scale version of the natural color VBMP image for the backdrop.

Stability at the shore is illustrated in plate “b”. The bank is characterized by its height, the amount of cover on the bank face, the state of erosion, and the presence or absence of natural buffers at the bank toe. Upland adjacent to high fully covered, and stable banks with a stable natural buffer at the base are less prone to flooding or erosion problems resulting from storm activity. Upland adjacent to banks of lesser height (< 5feet) are at greater risk of flooding, but if banks are stable with marshes or beaches present, erosion may not be a significant concern. Survey data reveals a strong correlation between banks of high erosion, and the absence of natural buffers. Conversely, the association between stable banks and the presence of marsh or beach is also well established. This suggests that natural buffers such as beaches and fringe marshes play an important role in bank protection. This is illustrated on the maps. Banks without natural buffers, yet classified as low erosion, are often structurally controlled with rip rap or bulkheads. Check plate “c” to verify this.

Plate “b” can be used to identify sites for BMPs. Look for where eroding bank conditions persist. The thickness of the line tells something about the bank height. The fetch, or the distance of exposure across the water, can offer some insight into the type of BMP that might be most appropriate. Marsh planting may be difficult to establish at the toe of a bank with high exposure to wave conditions. Look for other marsh fringe in the vicinity as an indicator. Plate “c” should be checked for existing shoreline erosion structures in place.

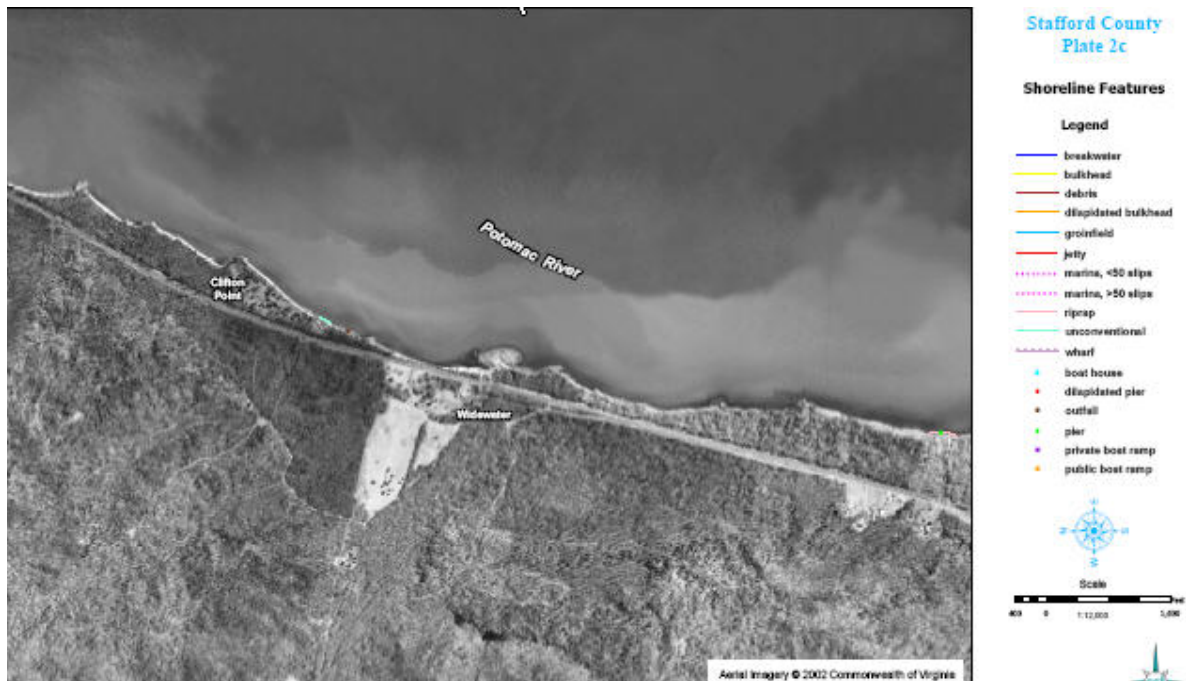
Figure 6. Map illustrating shoreline features for plate 2 in Stafford County

Plate C combines recreational and shoreline protection structures in a composition called Shoreline Features. Linear features, described previously (Table 3), are mapped using color coded bar symbols that follow the orientation of the shoreline. Point features use a combination of colors and symbols to plot the positions on the map. Grey scale VBMP imagery is used as a backdrop, upon which all shoreline feature data are superimposed.
