Westmoreland County, Virginia Shoreline Situation Report

Prepared By:
Comprehensive Coastal Inventory Program
Center for Coastal Resources Management
Virginia Institute of Marine Science, College of William and Mary
Gloucester Point, Virginia

June, 2007

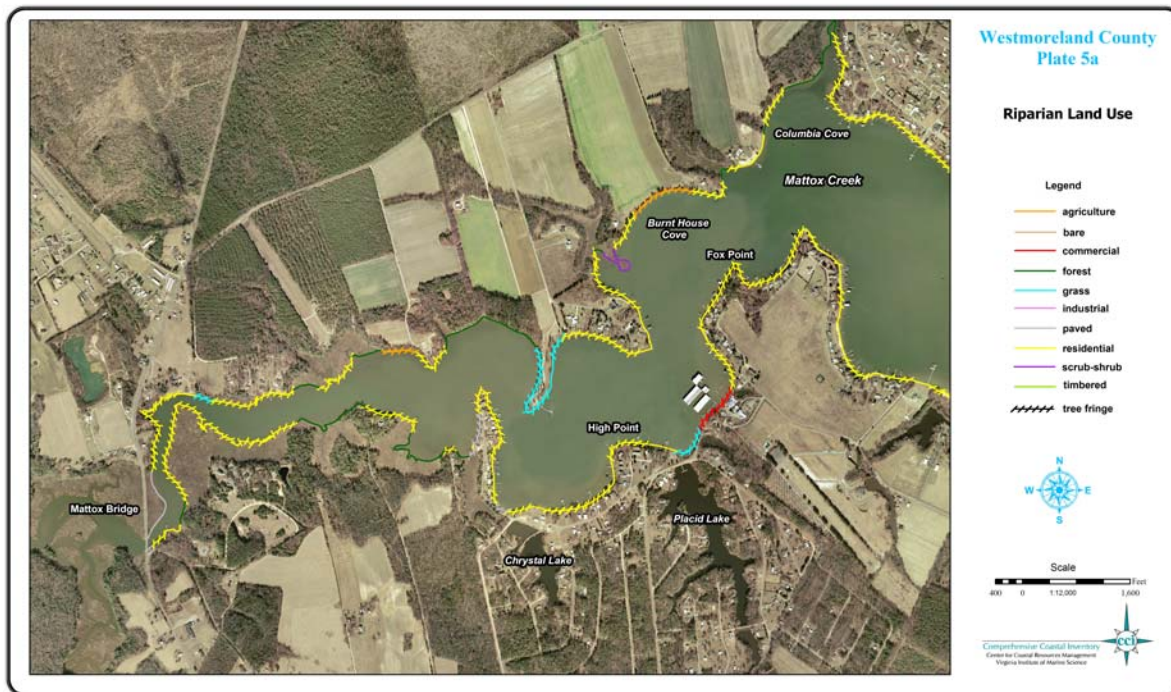
Figure 4. Sample riparian land use map for Westmoreland County

Plate A describes the riparian land use as color-coded bars along the shore. A legend keys the color to the type of land use. If the line is hatched, there is forest fringe on site. The background imagery is natural color VBMP imagery at a publication scale of 1:12,000. Users should note that the imagery is sometime rotated in order to meet the scale requirements. This means that “north” is not always to the top of the page.

For example, land use, to some extent, directs the type of management practices one can expect to find along the shoreline. The land use data, illustrated in plate “a” of the SSR series illustrates current land use at the time of survey that may be an indicator of shoreline management practices existing or expected in the future. Residential and commercial areas are frequently altered to counter act shoreline erosion problems or to enhance private access to the waterway. In contrast forested or agricultural uses are frequently unmanaged even if chronic erosion problems exist. Small forest tracks nestled among residential lots have a high probability for development in the future. These areas are also target areas then for shoreline modifications if development does occur. Local governments can do some enhanced and proactive planning if resources allow and the SSR data is readily available. Areas primed for

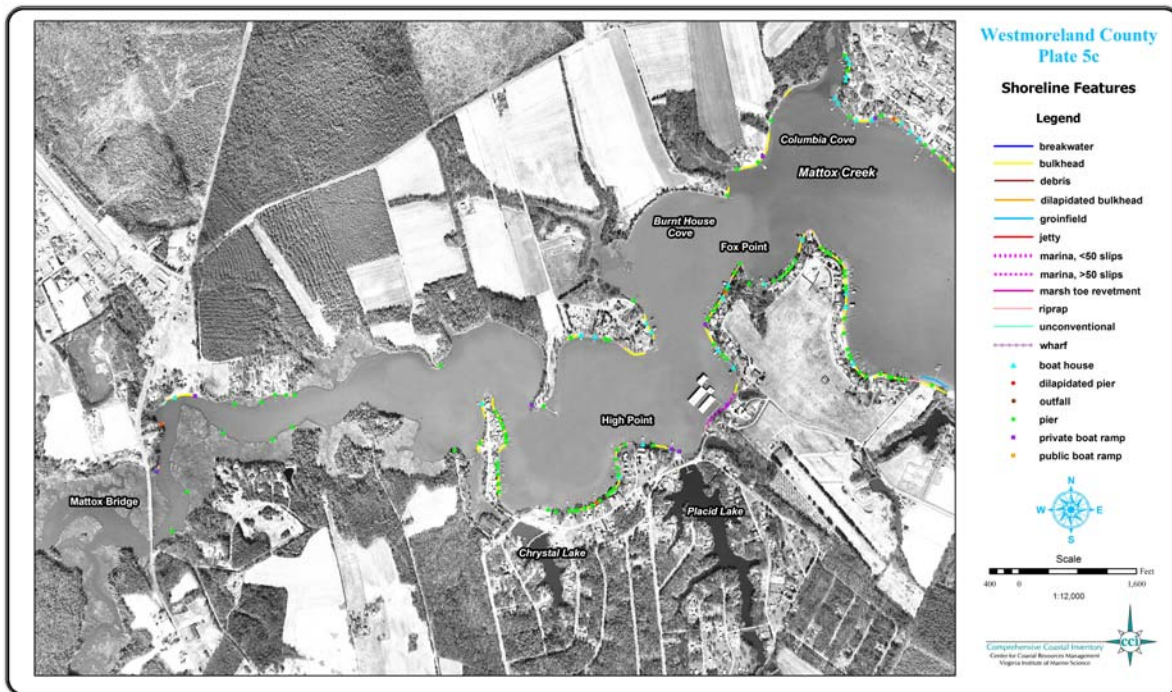
Figure 6. Map illustrating shoreline features for plate 5 in Westmoreland County

Plate C combines recreational and shoreline protection structures in a composition called Shoreline Features. Linear features, described previously (Table 3), are mapped using color coded bar symbols that follow the orientation of the shoreline. Point features use a combination of colors and symbols to plot the positions on the map. Gray scale imagery is used as a backdrop, upon which all shoreline feature data are superimposed.

Plate “c” delineates structures installed along the shoreline. These include erosion control structures, and structures to enhance recreational use of the waterway. This map is particularly useful for evaluating new requests from property owners seeking structural methods for controlling shoreline erosion problems. Shoreline managers can evaluate the current situation of the surrounding shore including: impacts of earlier structural decisions, proximity to structures on neighboring parcels, and the vicinity to undisturbed lots. Alternative methods such as vegetative control may be evaluated by assessing the energy or fetch environment from the images. Use this plate in combination with Plate B that indicates the qualitative erosion assessment made during the survey.
