City of Norfolk

Shoreline Situation Report

Prepared by: Comprehensive Coastal Inventory Program, Virginia Institute of Marine Science, College of William and Mary, Gloucester Point, VA 23062

Special Report in Applied Marine Science and Ocean Engineering, SRAMSOE No. 378

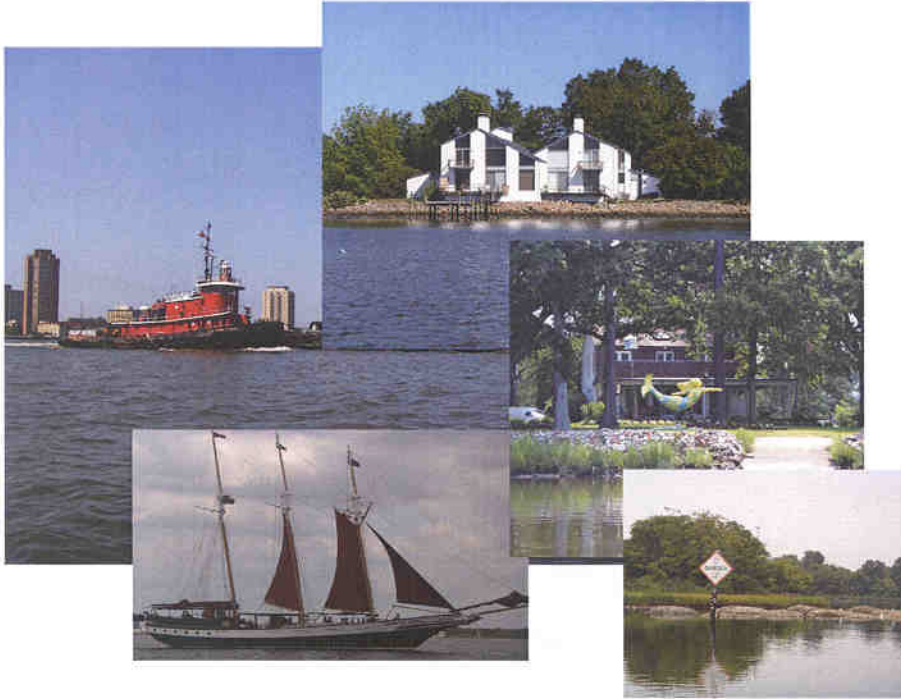
The City of Norfolk has approximately 54 square miles of land area, with 12.7 square miles of major surface water area (Figure 1). The city is located southeast of Hampton Roads, and borders Virginia Beach to the east, Chesapeake to the south, and Portsmouth to the southwest. The Elizabeth River divides Portsmouth and Chesapeake from Norfolk. The city's primary shoreline is along the Hampton Roads waterway, the Chesapeake Bay, and tributaries to the Elizabeth River. The Lafayette River, main stem of the Elizabeth River, and the Eastern Branch of the Elizabeth River comprise the major tidal tributaries. These all drain into Hampton
