# Development of the Maryland Shoreline Inventory Methods and Guidelines for Baltimore County and the City of Baltimore

Prepared by the Comprehensive Coastal Inventory Program,  
Center for Coastal Resources Management, Virginia Institute of Marine Science,  
College of William and Mary, Gloucester Point, Virginia.

This is a publication funded through the Maryland Coastal Zone Management Program,  
Department of Natural Resources, pursuant to NOAA Award No. 14-03-889 CZM049

October, 2004

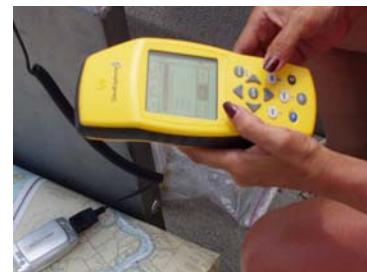
Data collection is performed in the field, from a small, shoal draft vessel, navigating at slow speeds parallel to the shoreline. To the extent possible, surveys take place on a rising tide, allowing the boat to be as close to shore as possible. The field crew consists of a boat operator, and one surveyor. The boat operator navigates the boat to follow the shoreline geometry. The boat operator logs information relevant to shoreline structures. The surveyor collects information pertinent to land use and bank condition. Data is logged using either the handheld Trimble GeoExplorer, GeoExplorer 3, or GeoXT GPS unit. These units are accurate to within 4 inches of true position with extended observations, and differential correction. This level of accuracy has not been achieved in this project due to the observation requirements. Both static and kinematic data collection is performed.

Kinematic data collection is a collection technique where data is collected continuously along a pathway (in this case along the waterway). GPS units are programmed to collect information at a rate sufficient to compute a position anywhere along the course. Features are collected at a rate of one observation every five seconds. Land use, bank condition, and linear shoreline structures are collected using this technique.

Static surveys pin-point fixed locations that occur at very short intervals. The boat actually stops to collect these data, and the boat operator must hold the boat against tidal current, and surface wind waves. Static surveys log 10 GPS observations at a rate of one observation per second at the fixed station. The GPS receiver uses an averaging technique to compute one position based on the 10 static observations. Static surveys are used to position point features like piers, boat ramps, and boat houses.
