# Gloucester County, Virginia Shoreline Inventory Report Methods and Guidelines

Special report in Applied Marine Science and Ocean Engineering No. 403 of the Virginia Institute of Marine Science

## Gloucester County - Shoreline Inventory Report

October, 2008

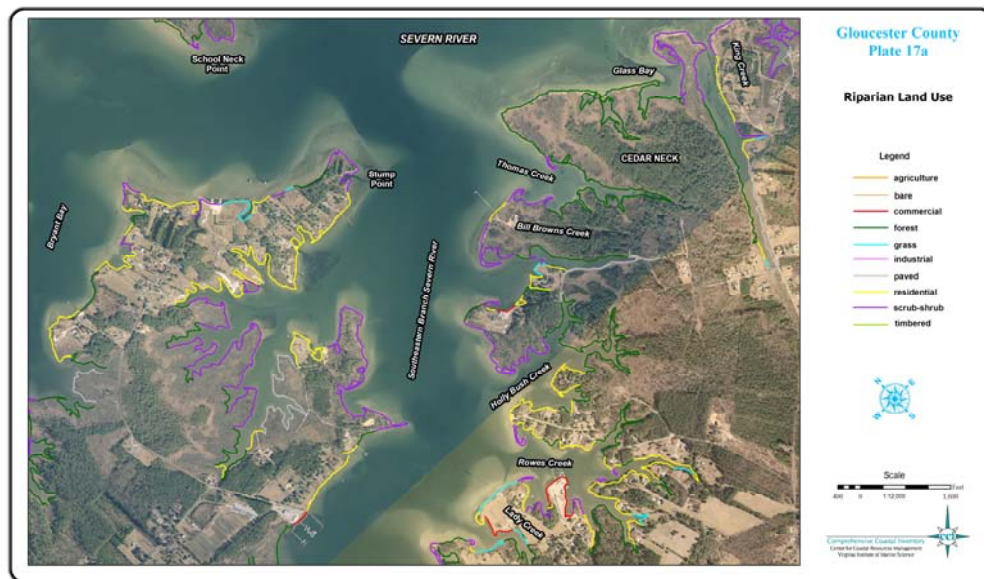
Figure 4. Sample riparian land use map for the Gloucester County

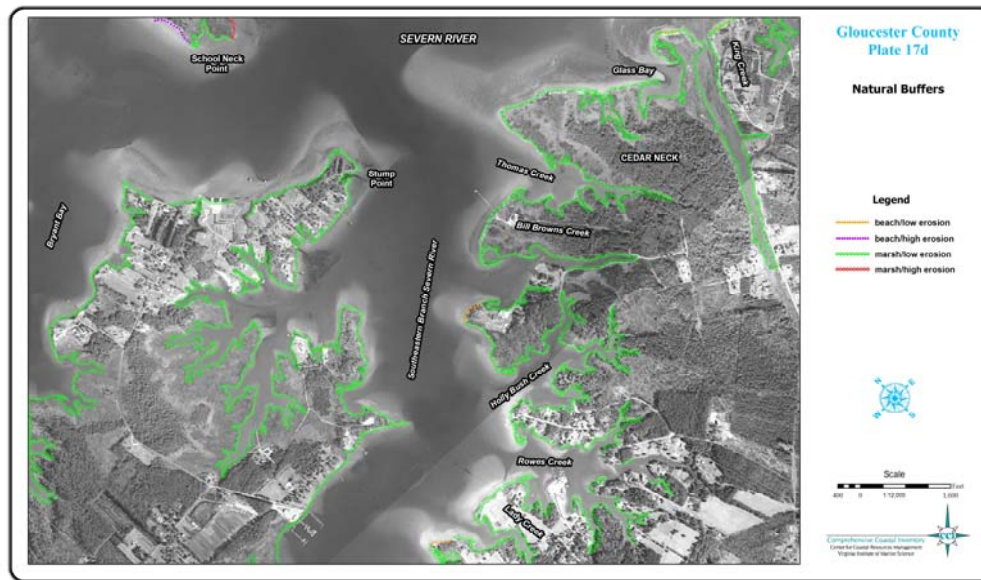
Figure 7. Map illustrating natural buffers for plate 17 in the Gloucester County

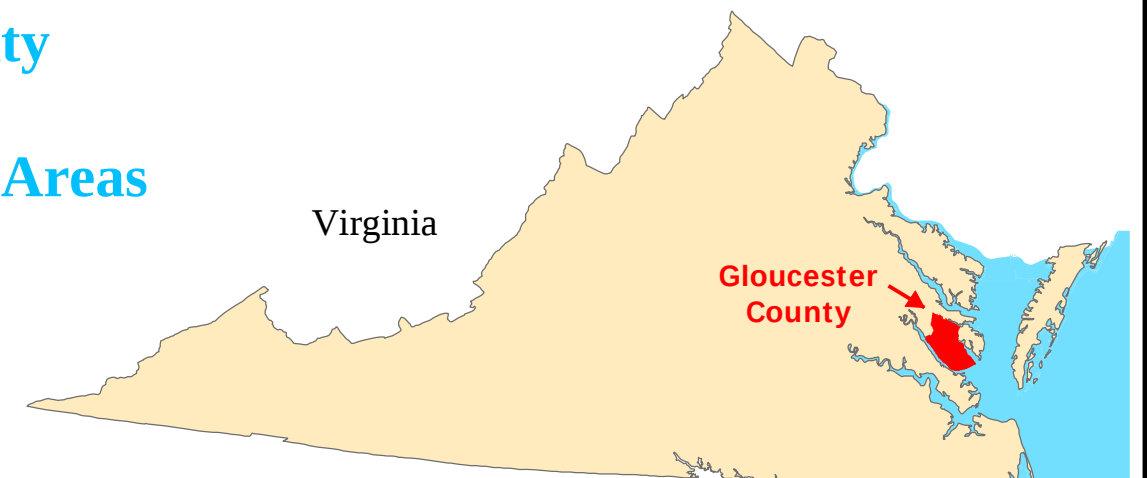
# Gloucester County Index Map for Remotely Coded Areas

- field coded shoreline
- remote coded shoreline
- remote coded access structure
