# King George, Virginia Shoreline Inventory Report Methods and Guidelines

Special report in Applied Marine Science and Ocean Engineering No. 407 of the Virginia Institute of Marine Science

## King George - Shoreline Inventory Report

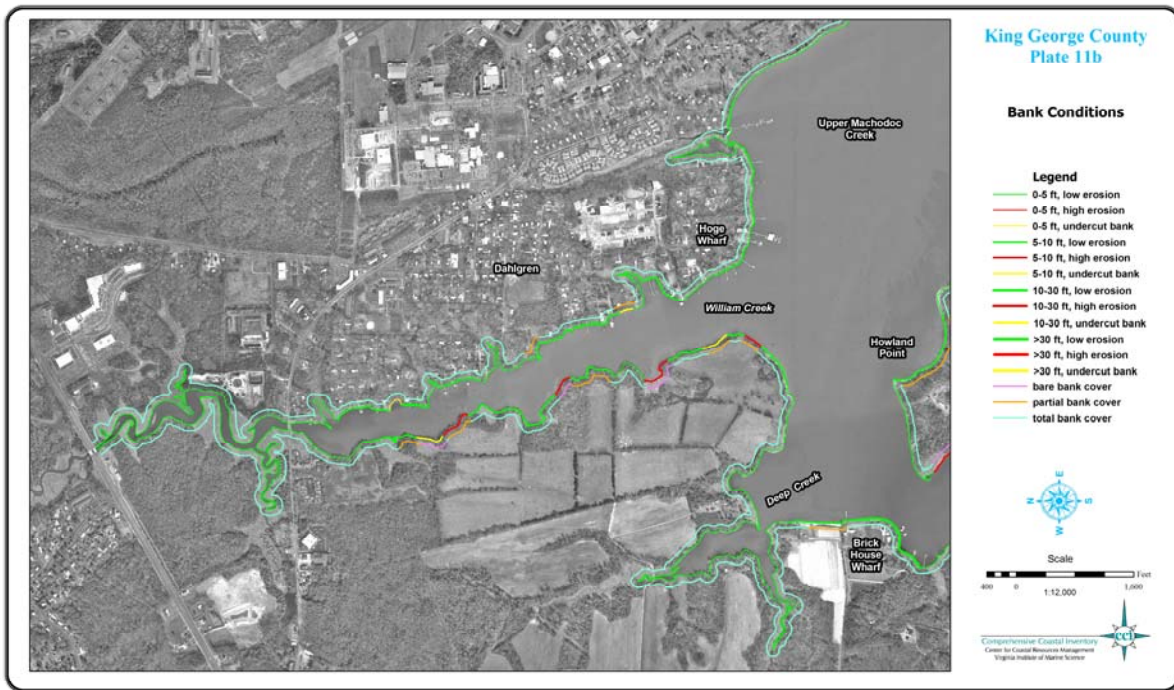
Figure 5. Map illustrating bank conditions for plate 11 in King George County

Plate B depicts the condition of the bank. The colors green, red and yellow are used to report if the bank is stable, unstable, or undercut, respectively. The thickness of the line reflects the bank height; where the thickest lines designate the highest banks (> 30 feet). Plate B uses a grey scale version of the natural color image for the backdrop.
